Hitomi Experience Report: Investigation of Anomalies Affecting the X-ray Astronomy Satellite “Hitomi” (ASTRO-H)

May 31, 2016

JAXA

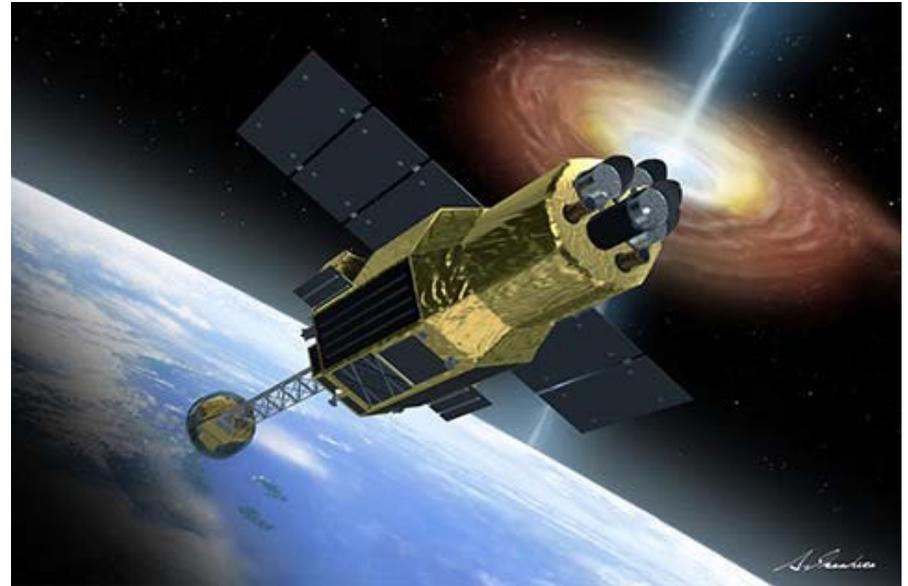
Illustration of ASTRO-H in orbit

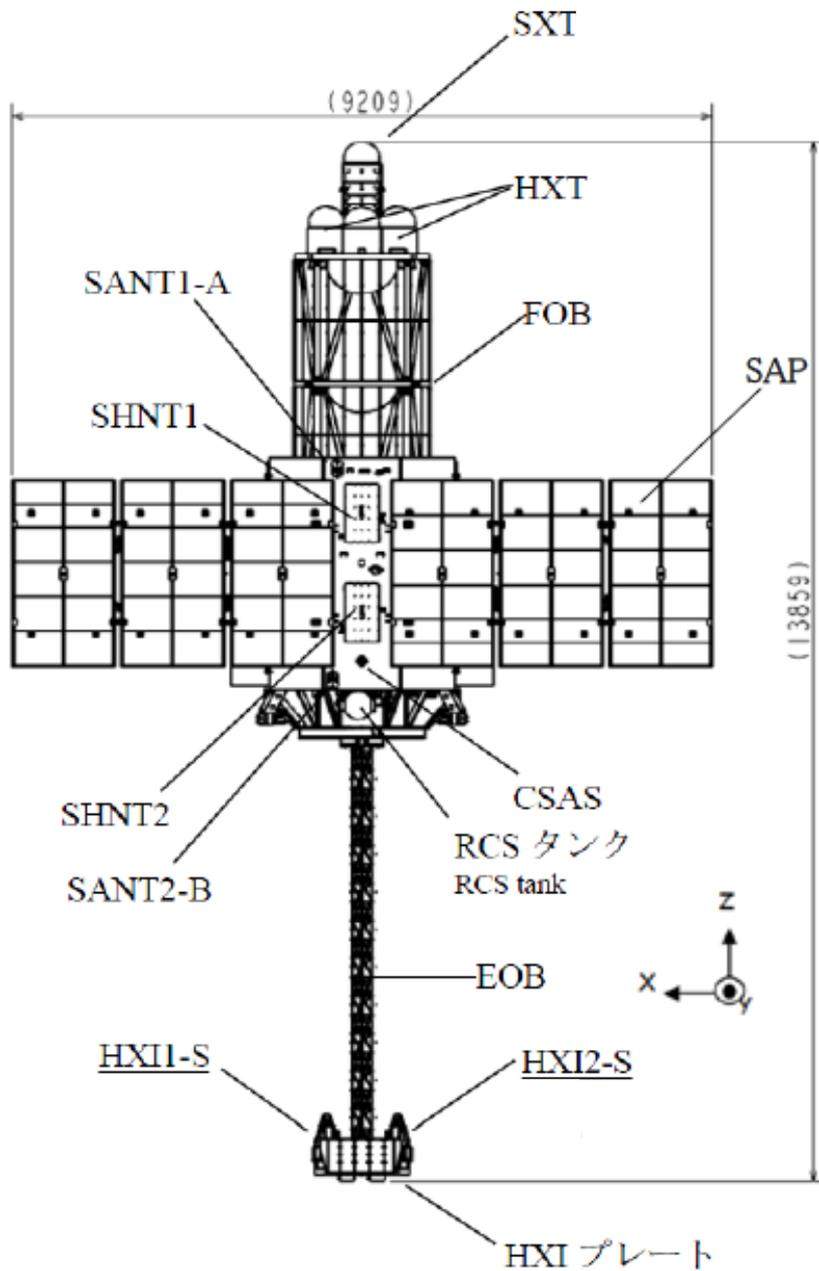
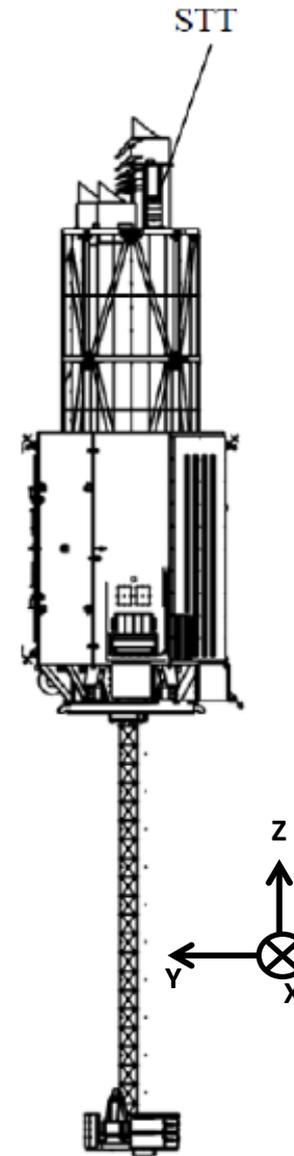
2.3 Exterior view of ASTRO-H satellite

abbreviation	Name
SXT	Soft X-ray telescope
HXT	Hard X-ray telescope
SANT	S-band Antenna
FOB	Fixed Optical Bench
SHNT	Shunt Dissipater
SAP	Solar Array Paddle
CSAS	Coarse Sun Aspect Sensor
RCS	Reaction Control System
EOB	Extensible Optical Bench
HXI	Hard X-ray Imager
STT	Star Tracker

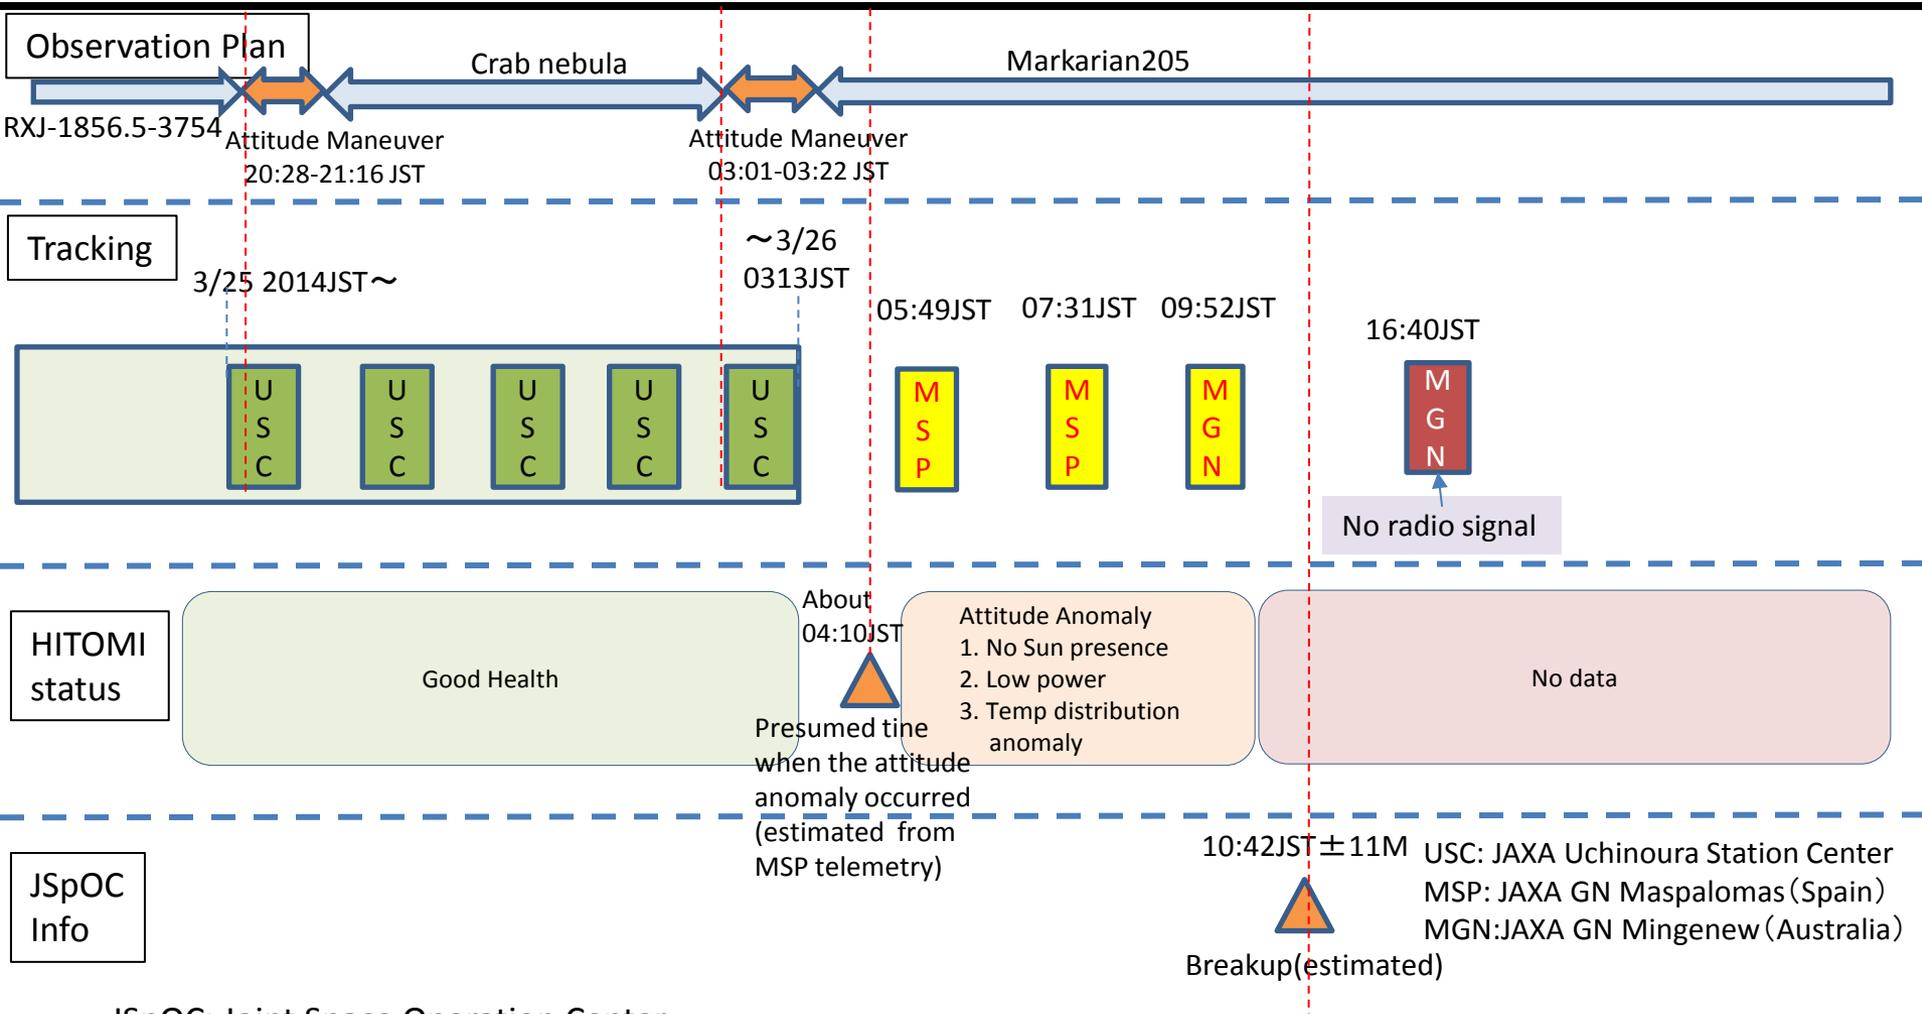
3.2 ASTRO-H Sequence of Event

The chart below shows a time sequence for the observation plan, satellite tracking, satellite condition on each events, and JSpOC information.

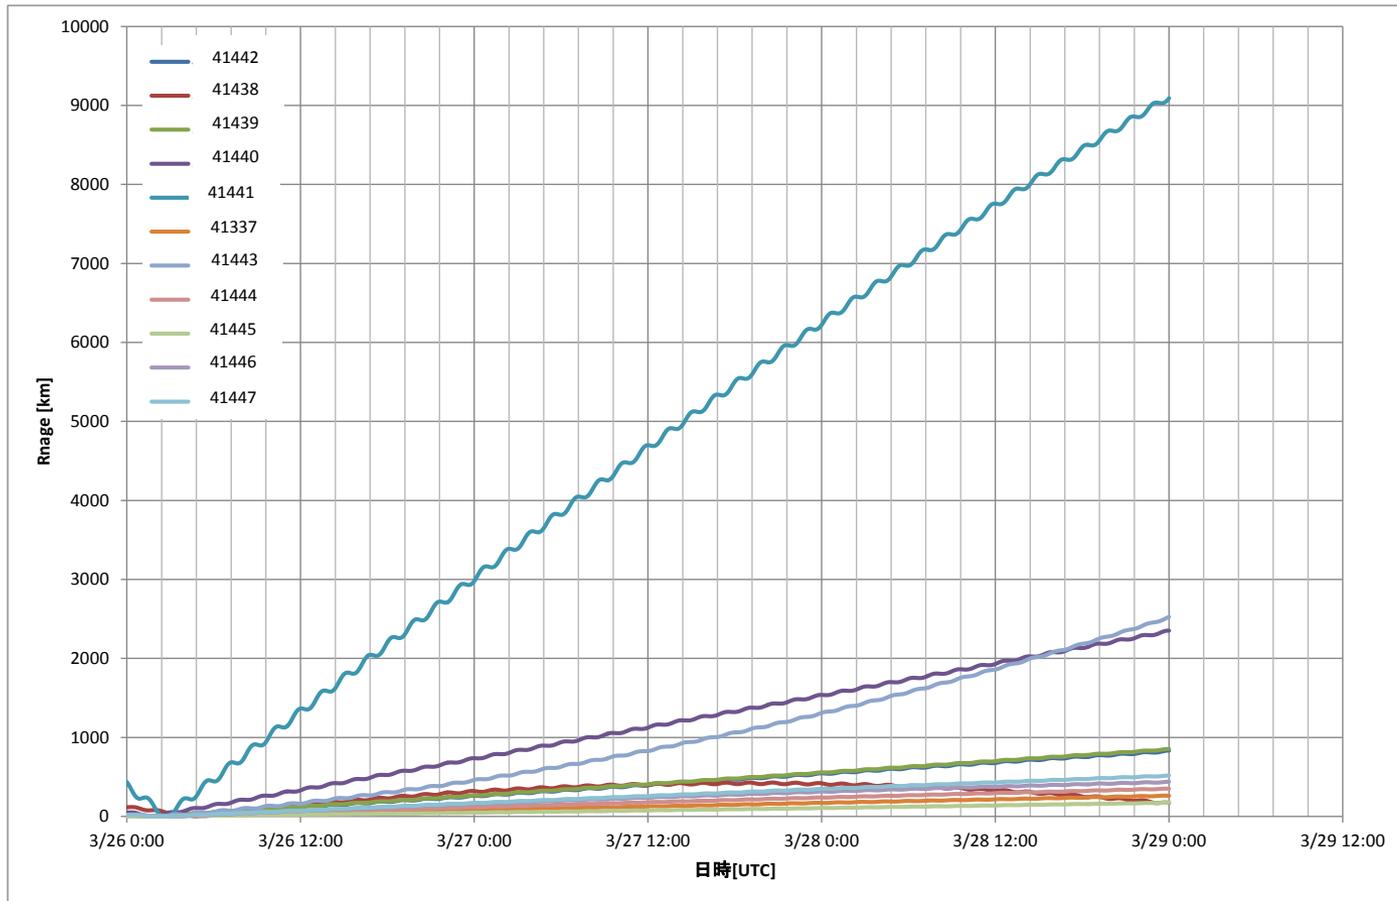
3.4 Observation results by ground telescope [1/3]

- JSpOC released the trajectory of the 11 objects on April 1. The largest piece should be identified as 41337. In this regards.
- By backtracking the trajectory of 11 objects, it is confirmed that they were on almost the same trajectory as ASTRO-H at 10:37 on 26 March. That shows that those objects are from ASTRO-H satellite.

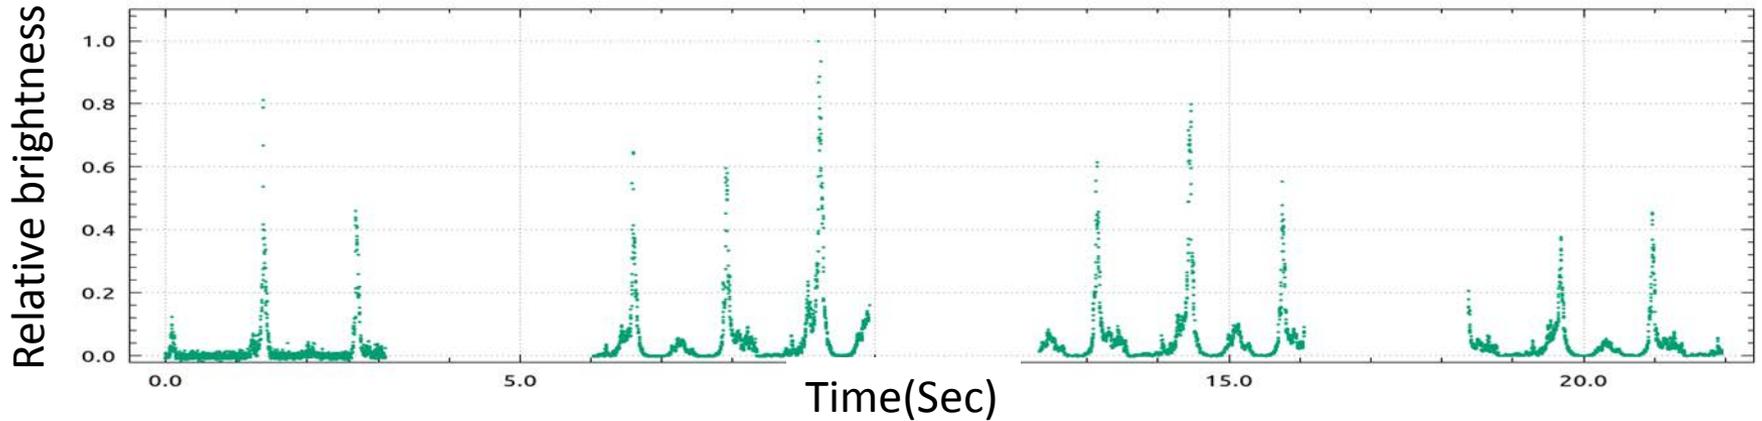
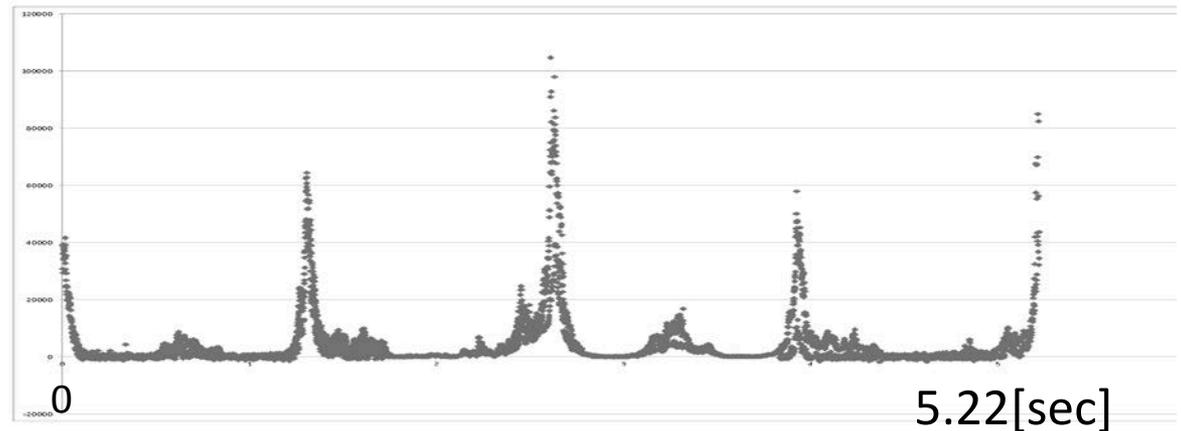
Light Curves observed by KISO Observatory

The number of seconds elapsed from 3/31 11:24:11.3

Upper Panel: Light curves observed by the proto-type of the Kiso wide field CMOS camera.

Right Panel: Result of the 5.22 sec period convolution

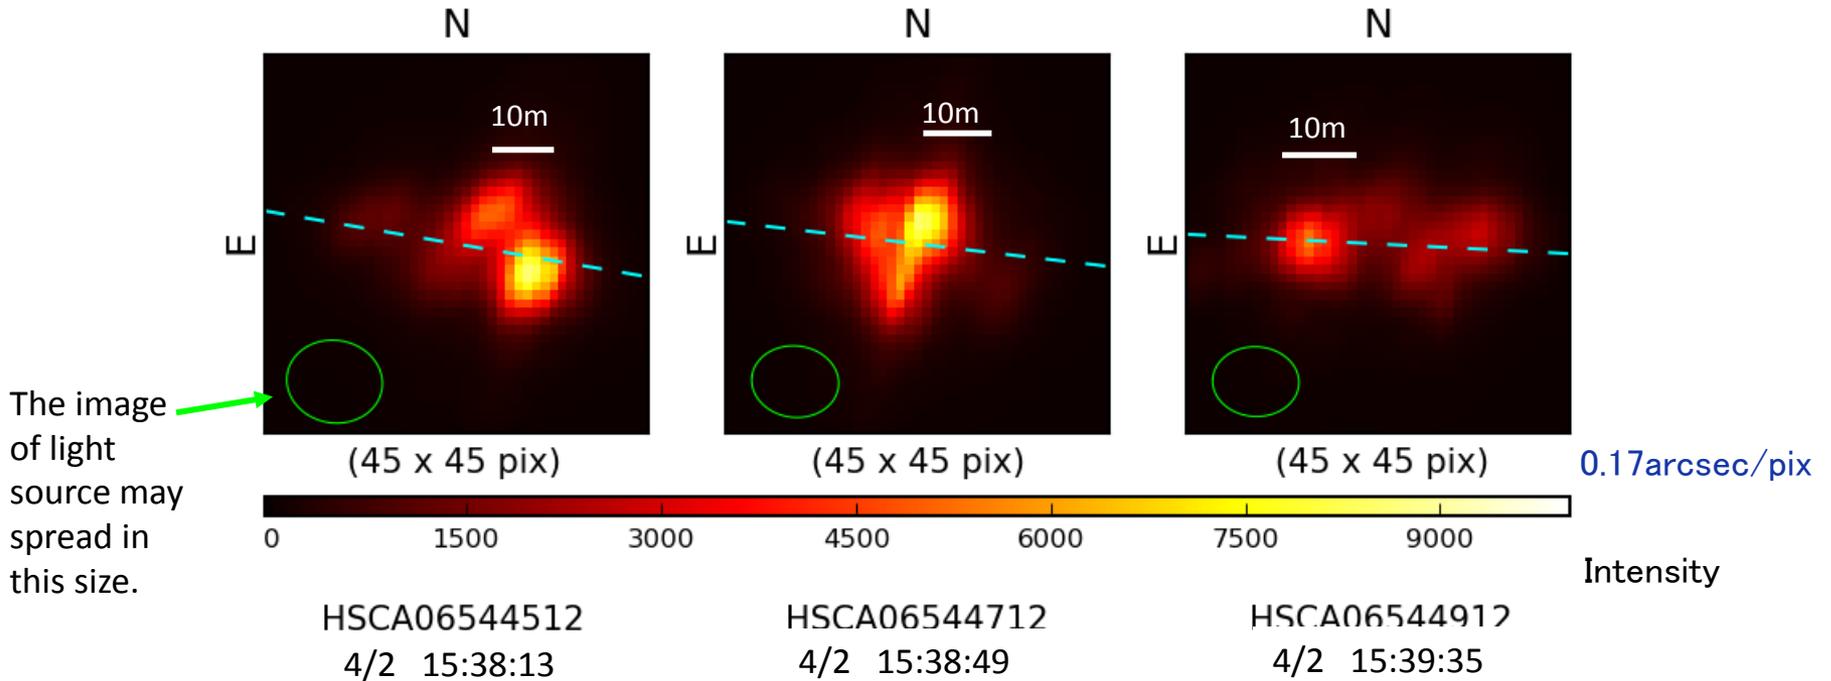
Observation images by Subaru Telescope

Although the resolution is not clear enough due to the low elevation of the target and the tracking error, the size of the bright pixels suggests that the object size of several meters. The details are under investigation.

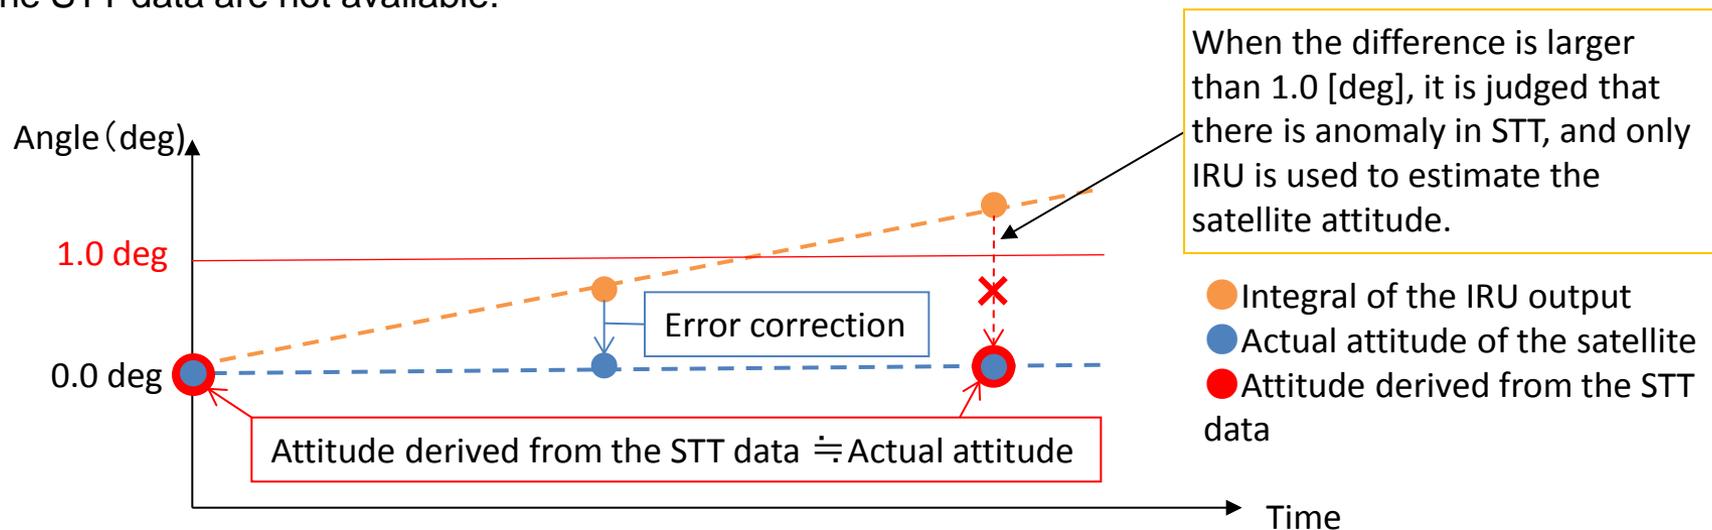
Appendix B: IRU Bias Rate Estimation

- IRU: a sensor to measure angular velocity [deg./sec] of a satellite along each axis(X, Y, and Z-axis)
- IRU values are integrated to determine the attitude of the satellite in the case of IRU only estimation, ex.) measurement:0.1[deg./sec], estimated attitude after 10 sec: $0.1 \times 10[\text{sec}]=1.0[\text{deg.}]$.
- The slight offset errors in the measured angular velocity are accumulated by the time integration. ex.) Error in the measurement:0.01[deg./sec] Attitude error after 10 sec: $0.01 \times 10=0.1\text{deg}$
- Comparing the attitude estimation with the STT of higher accuracy, the error trend of the IRU (shown in the orange line in the lower figure) is derived
- This error trend (the bias rate estimation) enables us to estimate the satellite's attitude accurately even if the STT data are not available.

Figure : the sketch of the process.

※STT: Optical device to estimate the attitude of a satellite based on stellar positions. A series of complicated calculation is required to derive the attitude from the STT data, and the frequency of its output is low. Contrary, the IRU 's output is speedy, because the derivation method of the attitude is simple.

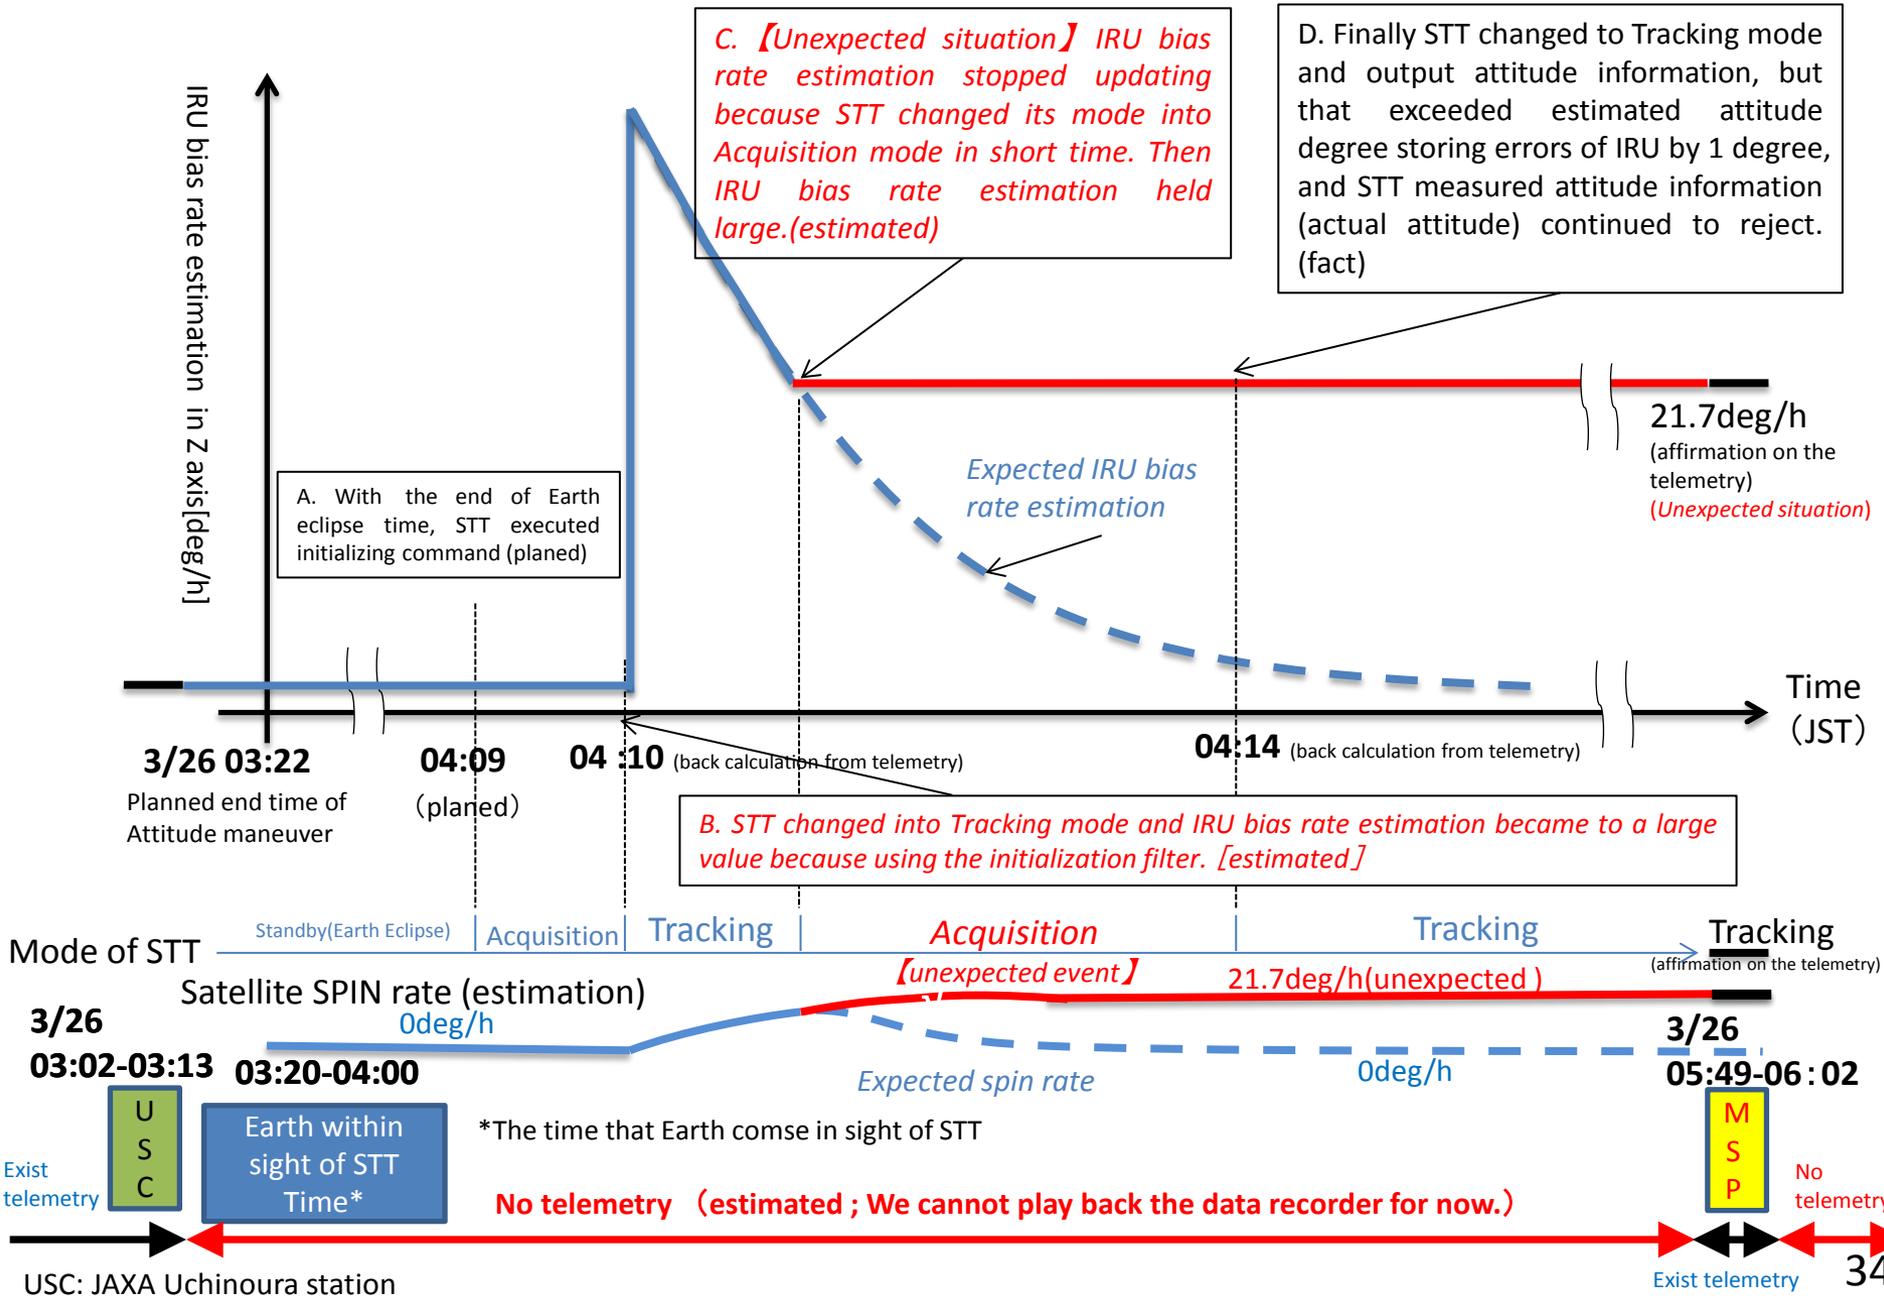
4.2 IRU Bias Rate behavior

- JAXA investigated the cause for IRU rate bias to remain larger by simulation based on STT mode change using on-board software. It was confirmed that the STT behavior as shown in Page 15, made IRU bias rate remain high.

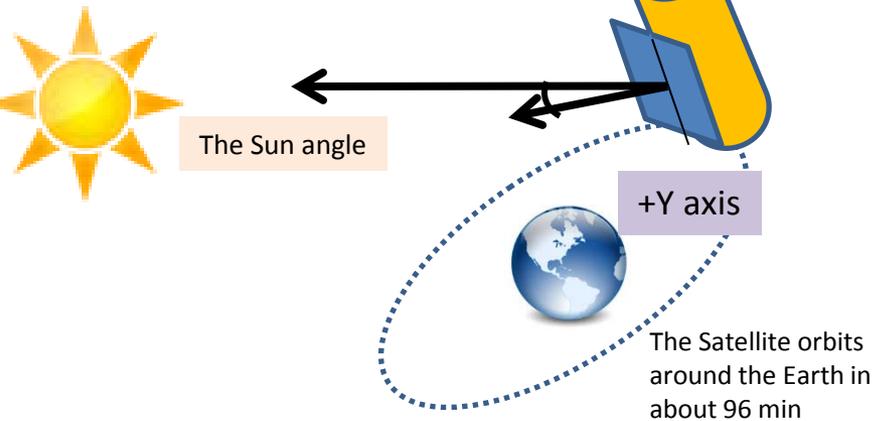
Normal

ASTRO-H is orbiting around the Earth with SAP facing the Sun to generate power. While keeping its attitude, ASTRO-H positions itself directed to the observation targets.
(There is invisible time that the satellite cannot see the observation targets because the Earth obstructs the sight of telescope.)

The nominal angle between satellite +Y axis and the Sun angle is within ± 30 degrees.

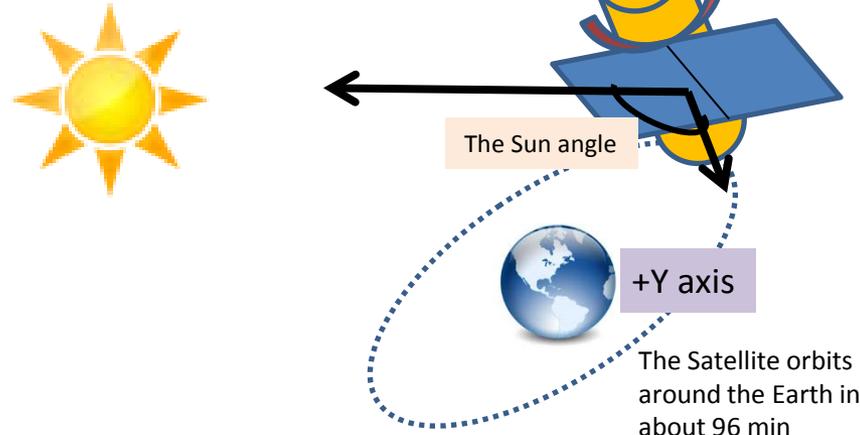
Attitude anomaly

The IRU estimated error value continues, and ASTRO-H began to rotate along Z axis about 21.7 degree/hour slowly. The Sun angle at a time of the last telemetry reception at MGN was about 123 degrees.

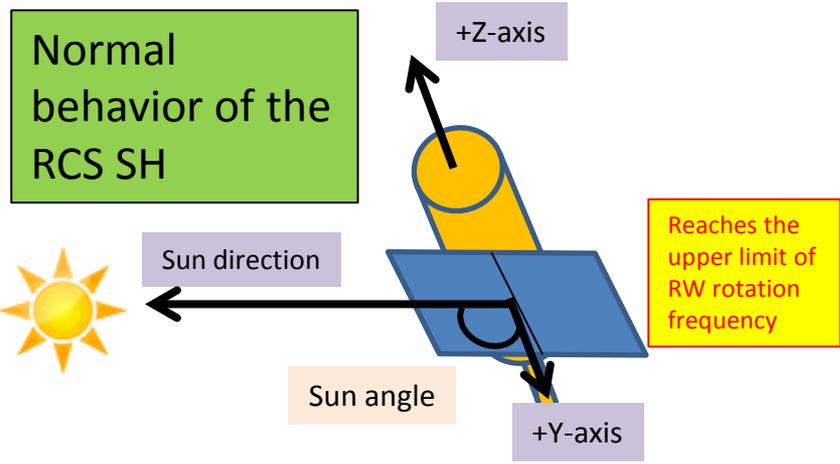
Appendix E: Schematic View of the Satellite's Behavior at Anomalies 3 and 4

From 10:04 March 26th (after MGN pass) to 10:37 (the break-up time estimated by JAXA)

Estimated behavior of the RCS SH in this anomaly

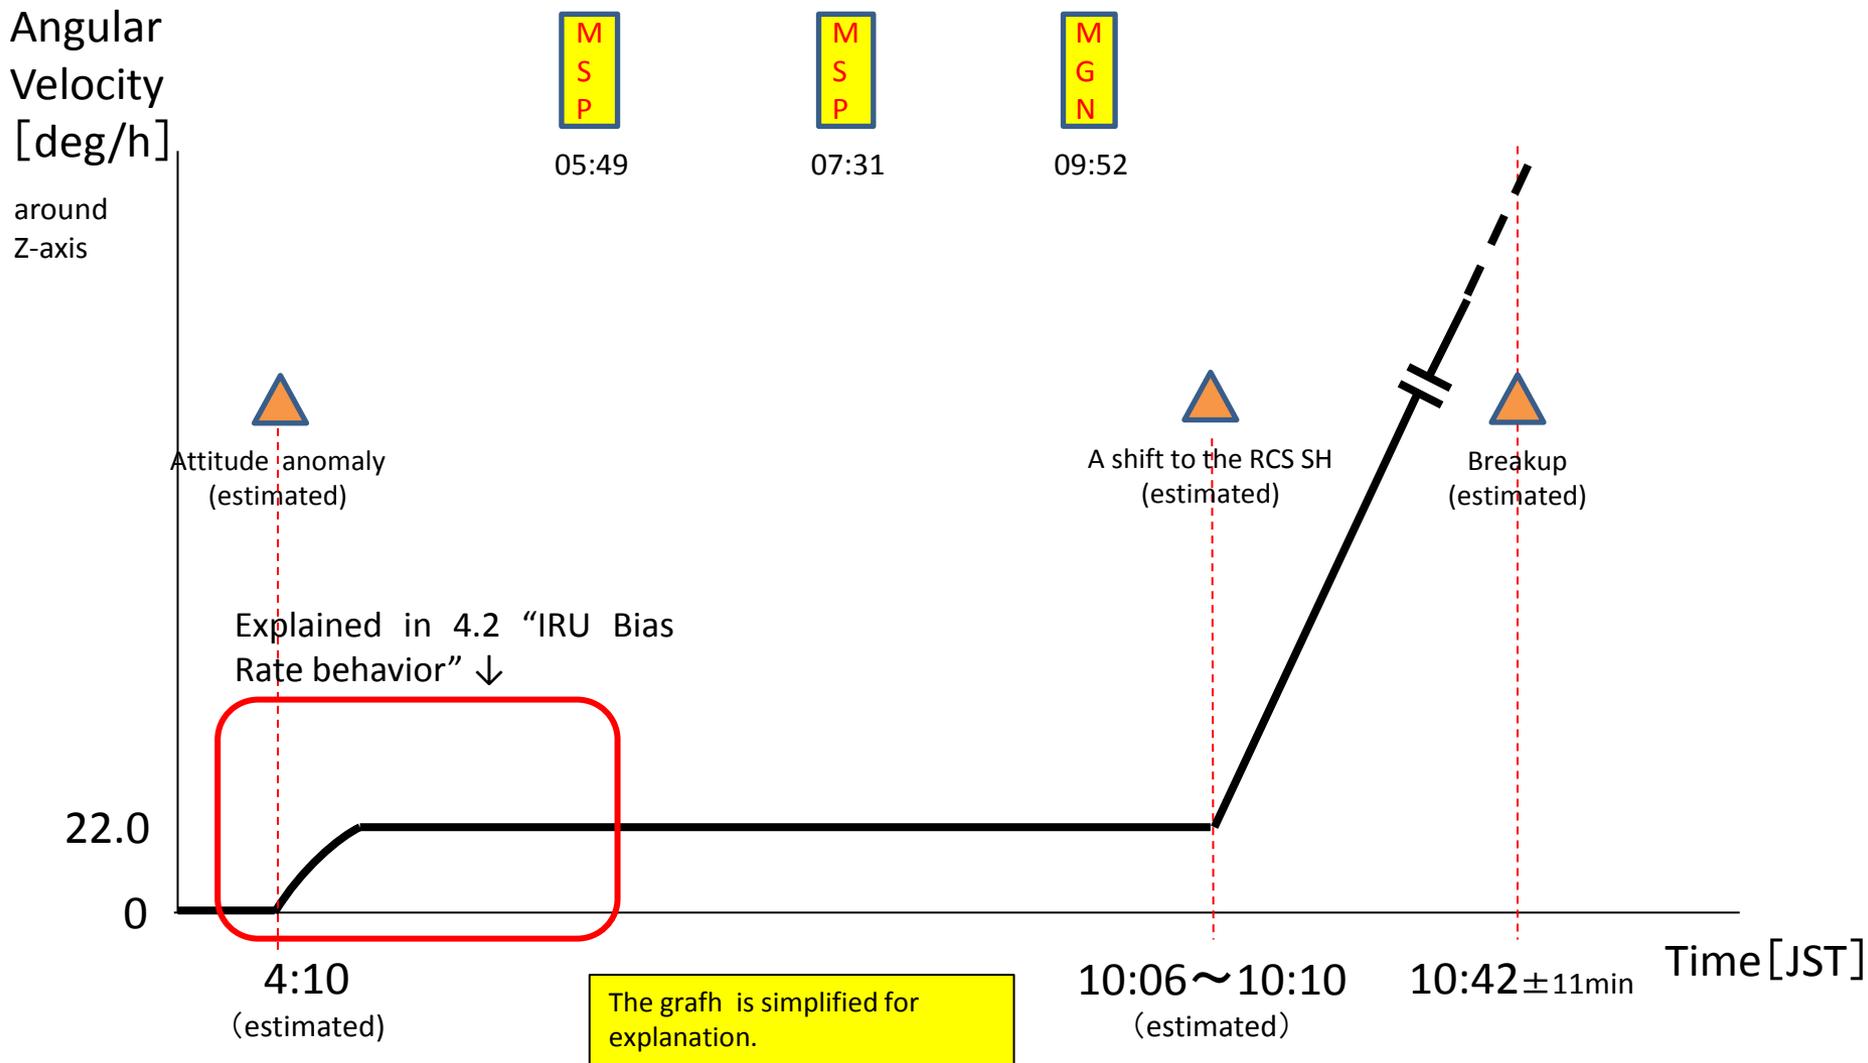
Appendix F: Behavior on ASTRO-H angular velocity around Z-axis

(from the end of the Attitude Maneuver)

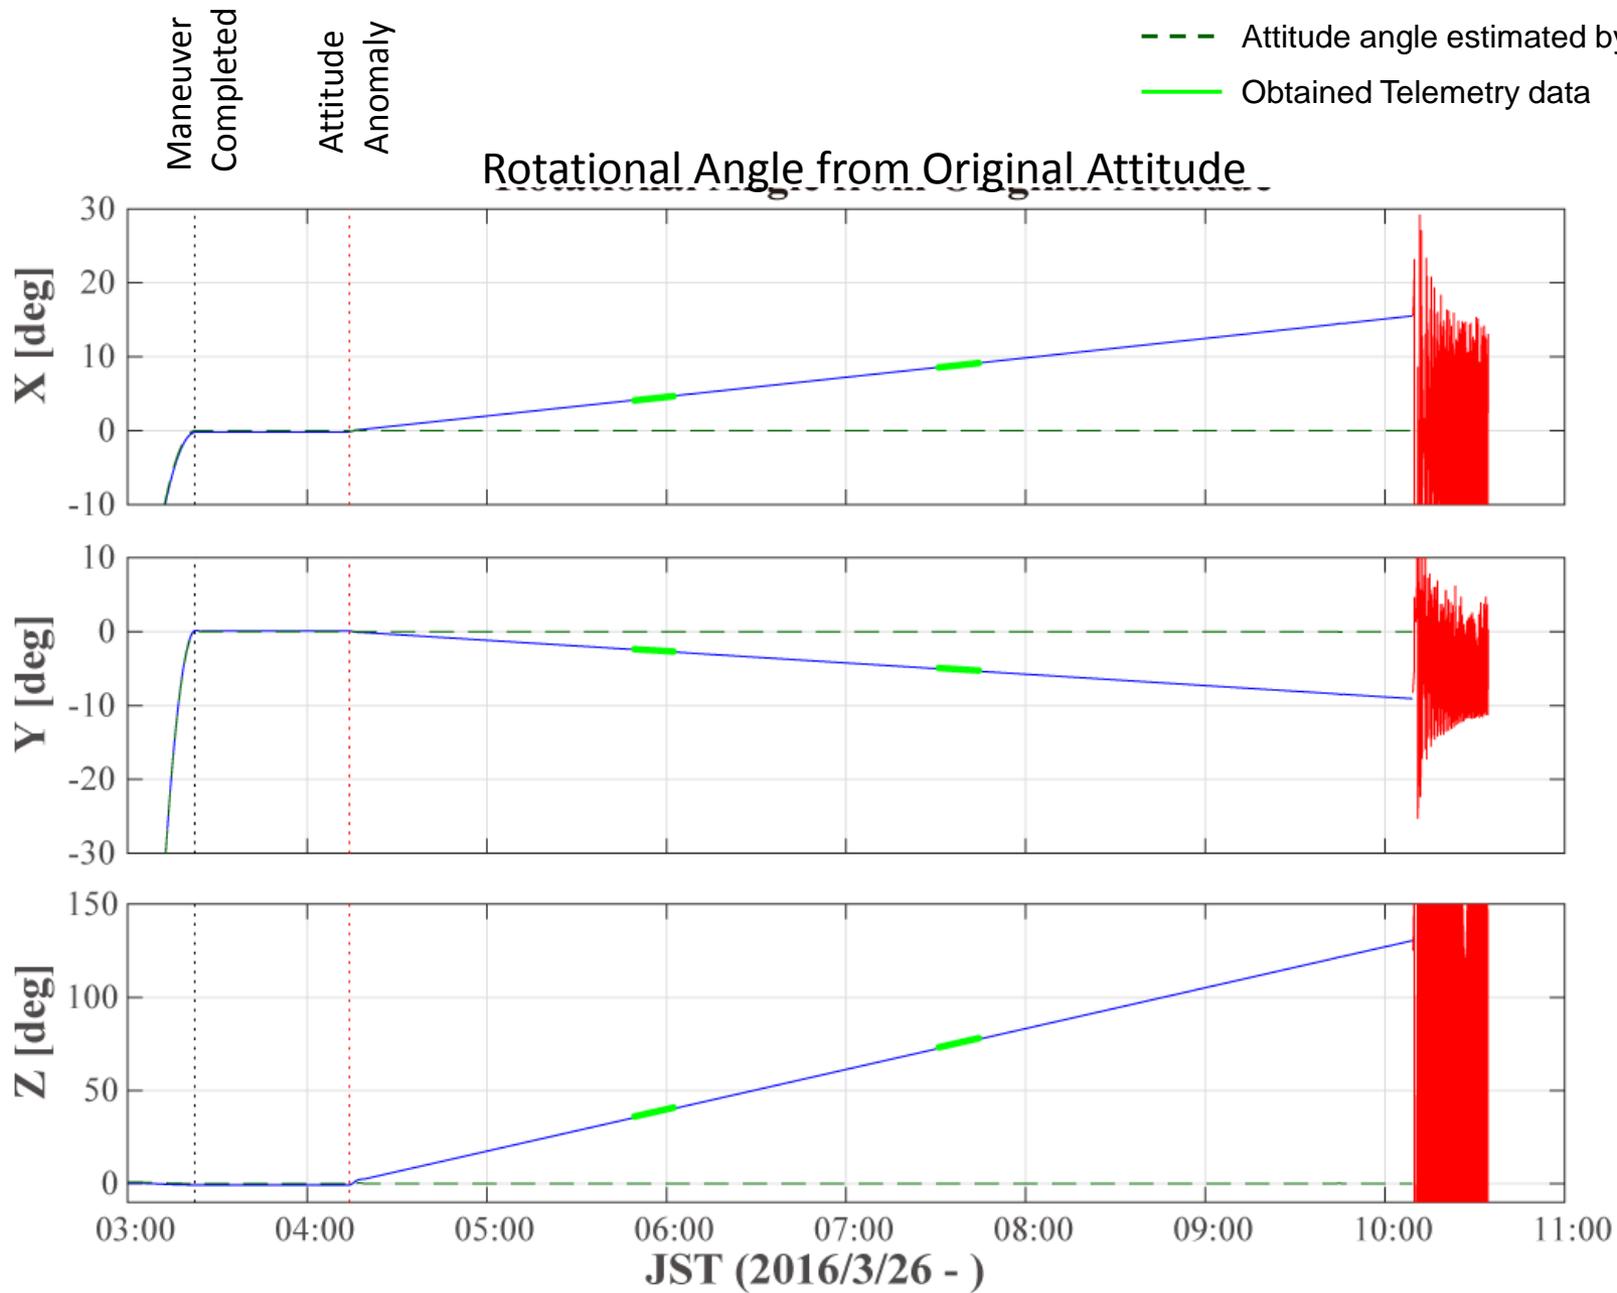
Appendix H: Attitude Angle of ASTRO-H

- Simulation results before RCS SH
- Simulation results after RCS SH
- - - Attitude angle estimated by ACS
- Obtained Telemetry data

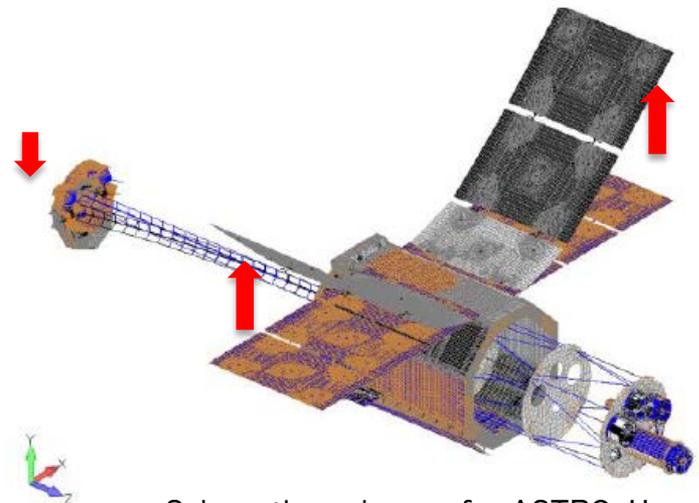
Schematic view of ASTRO-H rotating around the Z-axis

- JAXA estimated that the increase in the angular velocity of the satellite resulted in separation of the parts that were vulnerable to large rotational loads, such as the SAPs and EOB.
- According to investigation results, it is more likely that both the SAPs broke off at their base than that a part of the SAPs separated.
 - Detailed structural analysis of the SAPs by the finite element method showed that the SAP base was the part most vulnerable to rapid rotation.
 - The critical angular velocity for breaking of the SAP base was roughly consistent with that derived from ground-based observations conducted by observatories that JAXA asked for support.
- JAXA conducted the same analysis for EOB and concluded that EOB and the instruments attached at the top also separated from the main body. (Supplement 1)

Part	Rotation Axis	ω_{max} [deg/s]	Part
SAP	Z	150	SAP base
	X	150	SAP base
EOB	Z	125	Satellite side end of EOB
	X	90	EOB (each step)
	Y	90	EOB (each step)

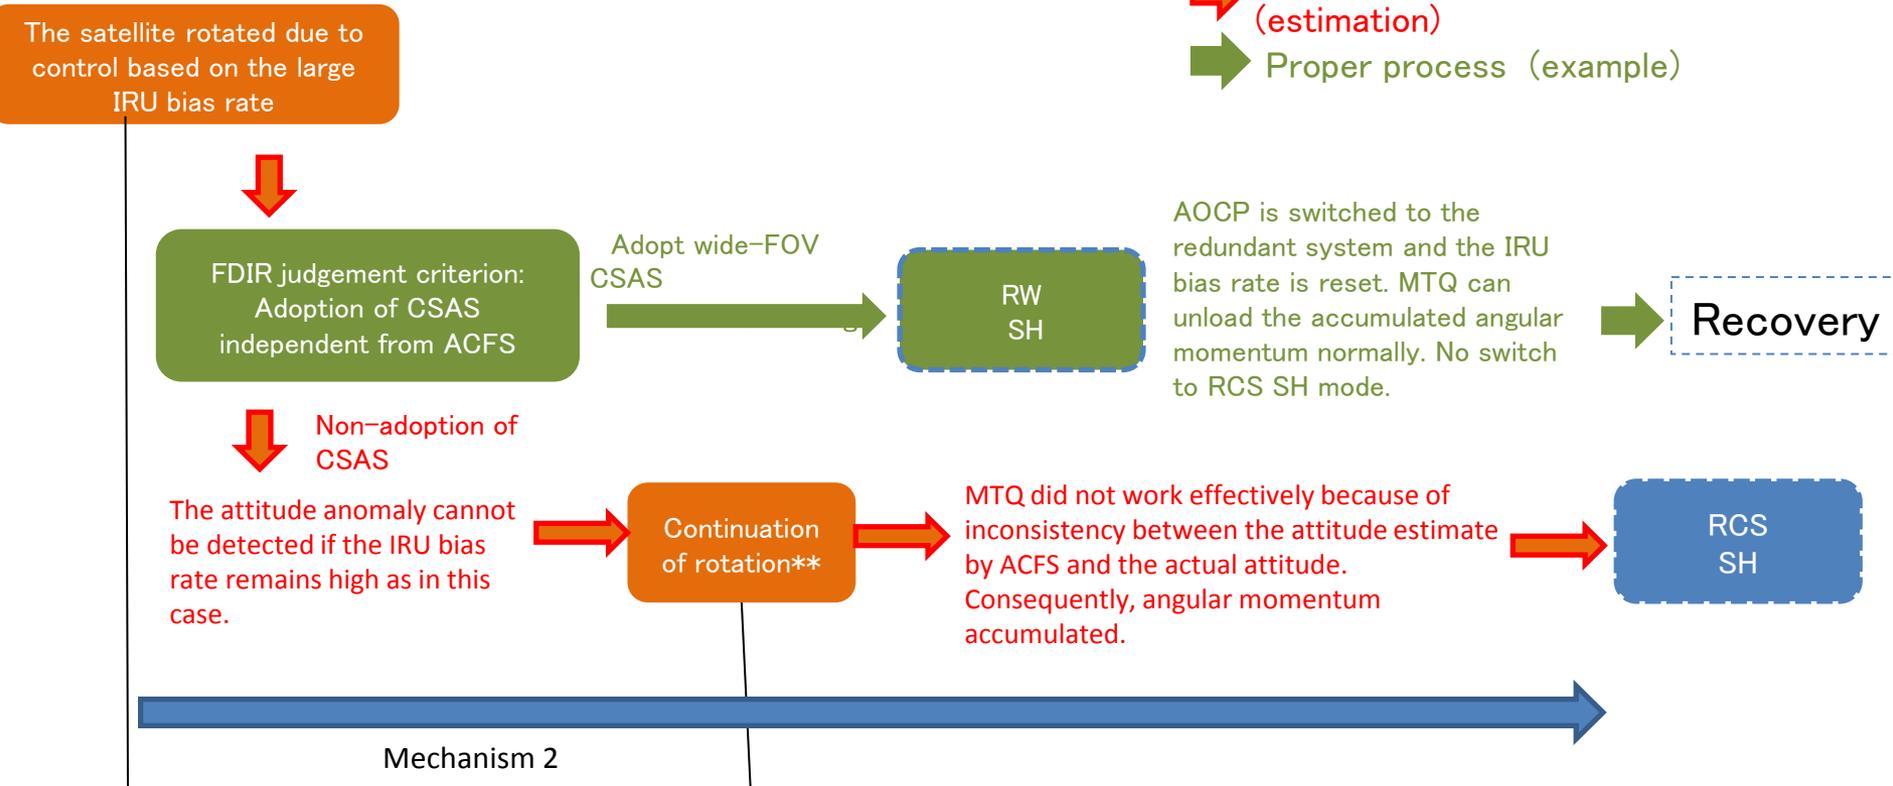
FDIR Design

- The attitude anomaly (the anomaly of the IRU bias rate) could not be detected because the satellite was designed to rely on only the ACFS estimates (not use CSAS) to detect an anomaly of the sun direction and switch to the SH attitude. Consequently, the attitude anomaly continued.
- Unloading by the MTQ failed due to the attitude anomaly. This led accumulation of RW angular momentum, which ultimately exceeded the upper limit (120 Nms). At this time, the satellite detected some anomaly of control by RW and switched to the RCS SH, in which thrusters were used for attitude control.

- ➡ Process when the events occurred (estimation)
- ➡ Proper process (example)

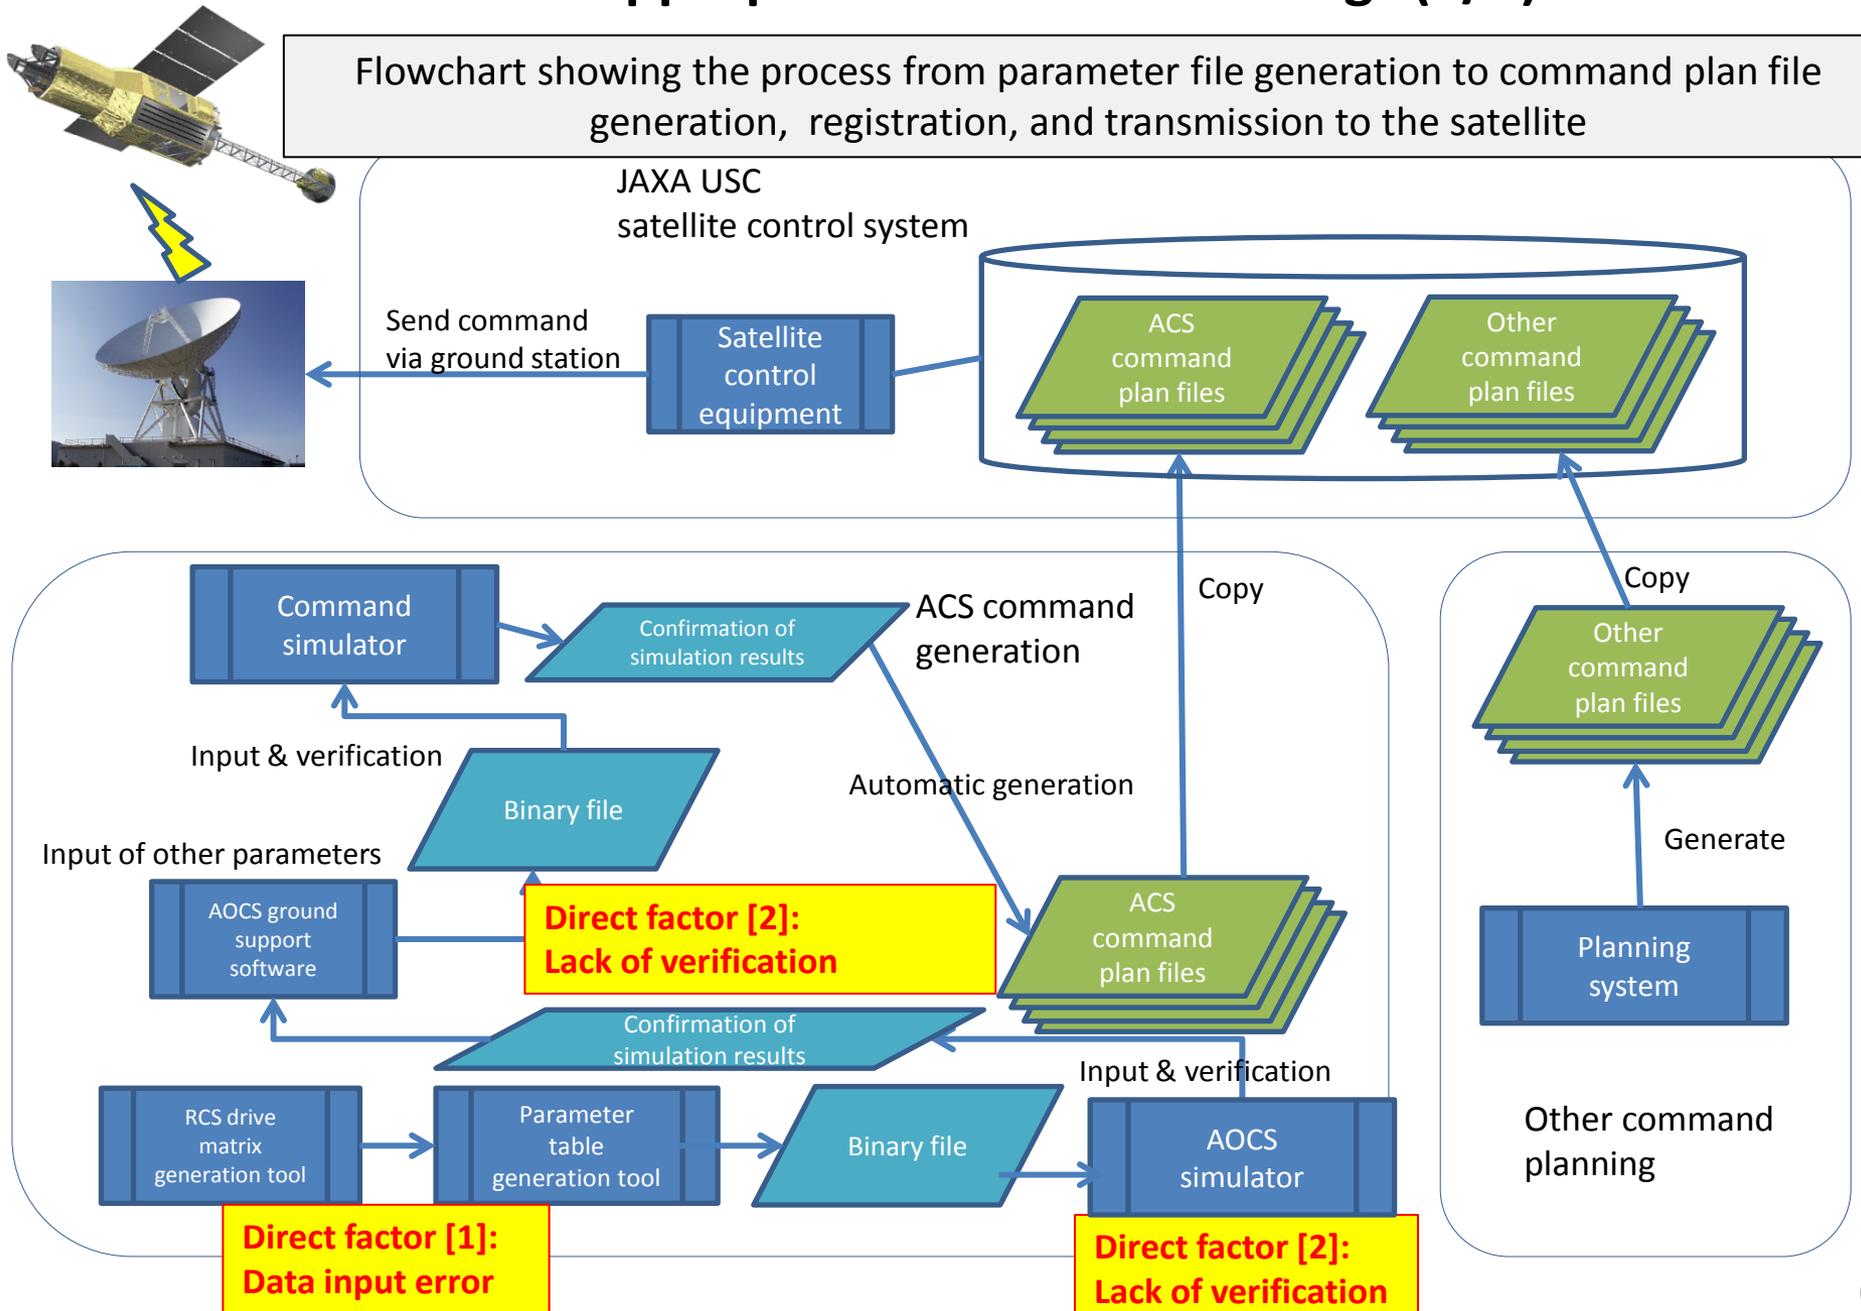
5.1.4 Inappropriate Parameter Settings (3/5)

Flowchart showing the process from parameter file generation to command plan file generation, registration, and transmission to the satellite
