Hitomi Experience Report: Investigation of Anomalies Affecting the X-ray Astronomy Satellite “Hitomi” (ASTRO-H)

May 31, 2016

JAXA

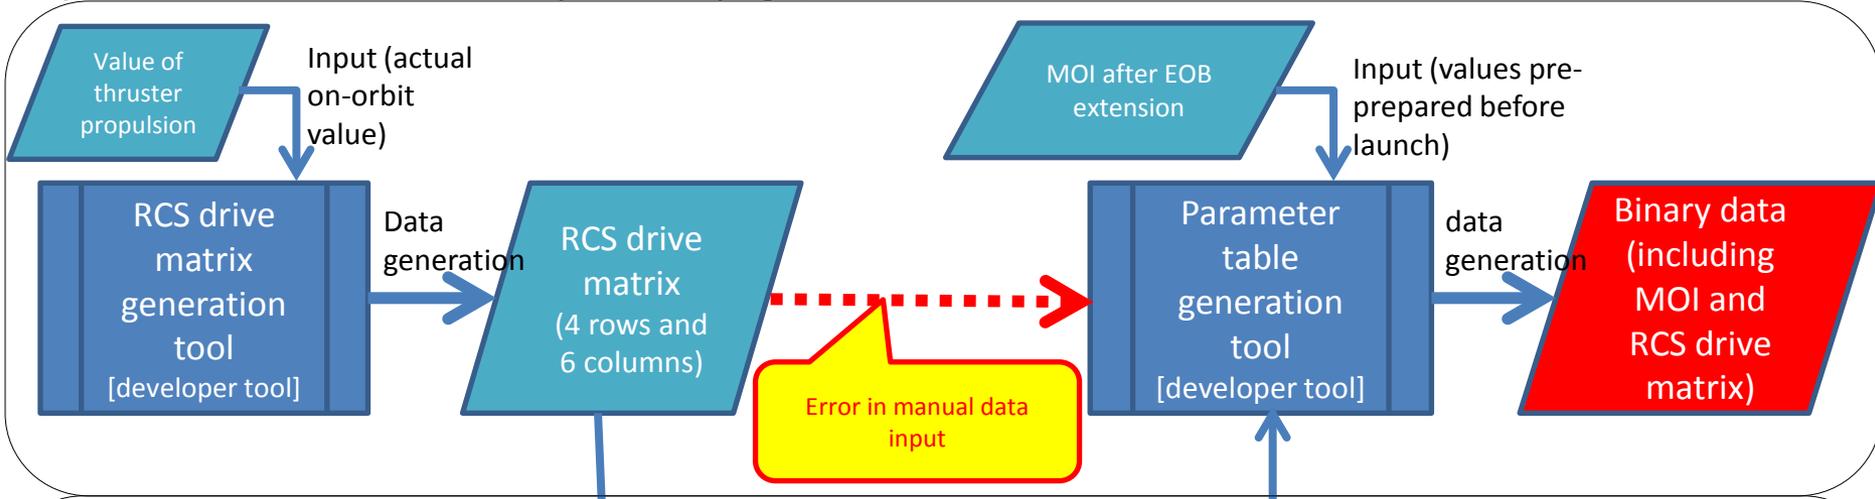
5.1.4 Inappropriate Parameter Settings (4/5)

Flowchart showing the process for command file generation on Feb 25 (expanding the bottom left part of the flowchart on the previous page)

Output of the "RCS drive matrix generation tool"

0.153748	0.000000	0.178475	0.000000	0.134816	0.000000
0.153748	0.000000	0.000000	-0.177997	0.000000	-0.134816
0.000000	-0.152615	0.000000	-0.177997	0.134816	0.000000
0.000000	-0.152615	0.178475	0.000000	0.000000	-0.134816

- The support company did not use the simulator to verify the generated thruster control parameters.
- An operator in charge from the support company made an orally asked another operator to run the simulation, but failed to indicate the necessity of verification for the change in thruster control parameter. Verification of the results was not performed.
- JAXA did not do a final check of operational readiness regarding the change of thruster control parameters.
- Neither the support company nor JAXA did not define a process for confirming verification results in order to proceed further. The process to confirm the verification results (or verification act) was also not clarified.

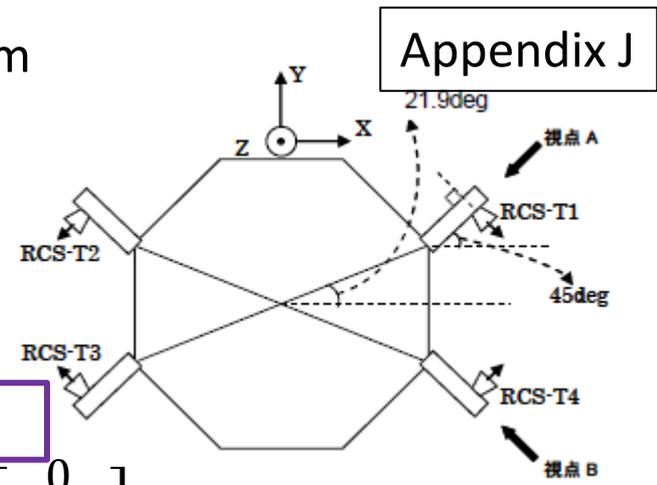
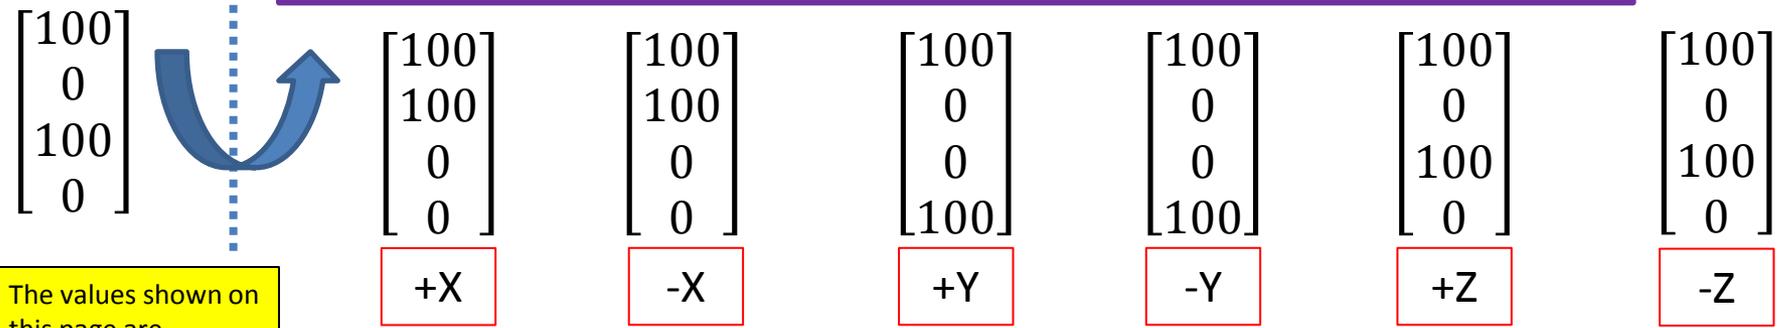
Appendix J: Overview of satellite behavior resulting from the "inappropriate part of the RCS control parameter settings"

Below is an overview of the satellite's behavior when inappropriate parameters were set. All values should be positive for coefficients to determine thruster injection duration for a negative torque. However, some negative values were input in this case.

Ex.) If the -Z torque request value was set to 100 Nms

RCS-T1 injection time (s)	$= \begin{bmatrix} 1 & 0 & 1 & 0 & 1 & 0 \\ 1 & 0 & 0 & -1 & 0 & -1 \\ 0 & -1 & 0 & -1 & 1 & 0 \\ 0 & -1 & 1 & 0 & 0 & -1 \end{bmatrix} \begin{bmatrix} 0 \\ 0 \\ 0 \\ 0 \\ 0 \\ 100 \end{bmatrix}$	+X torque product request (Nms)
RCS-T2 injection time (s)		-X torque product request (Nms)
RCS-T3 injection time (s)		+Y torque product request (Nms)
RCS-T4 injection time (s)		-Y torque product request (Nms)
		+Z torque product request (Nms)
		-Z torque product request (Nms)

If each torque request value is 100, the following is obtained.

As a result, even if the torque request is set around the negative axis, the result becomes the positive direction for thruster injections and acceleration continues in one direction around all XYZ three axes.
